I-75 KENTON COUNTY SLIDE
KYHPR ⁴⁸⁵ 63-16, HPR-1(4), PART II

Herbert F. Southgate
⁴⁷⁰
Research Engineer

SUBJECT: Research Report (Interim);
"I 75, Kenton County Slide;" HPR-1(4),
Part II; KYHPR-63-16

I 75, KENTON COUNTY SLIDE
KYHPR 63-16, HPR-1(4), Part II

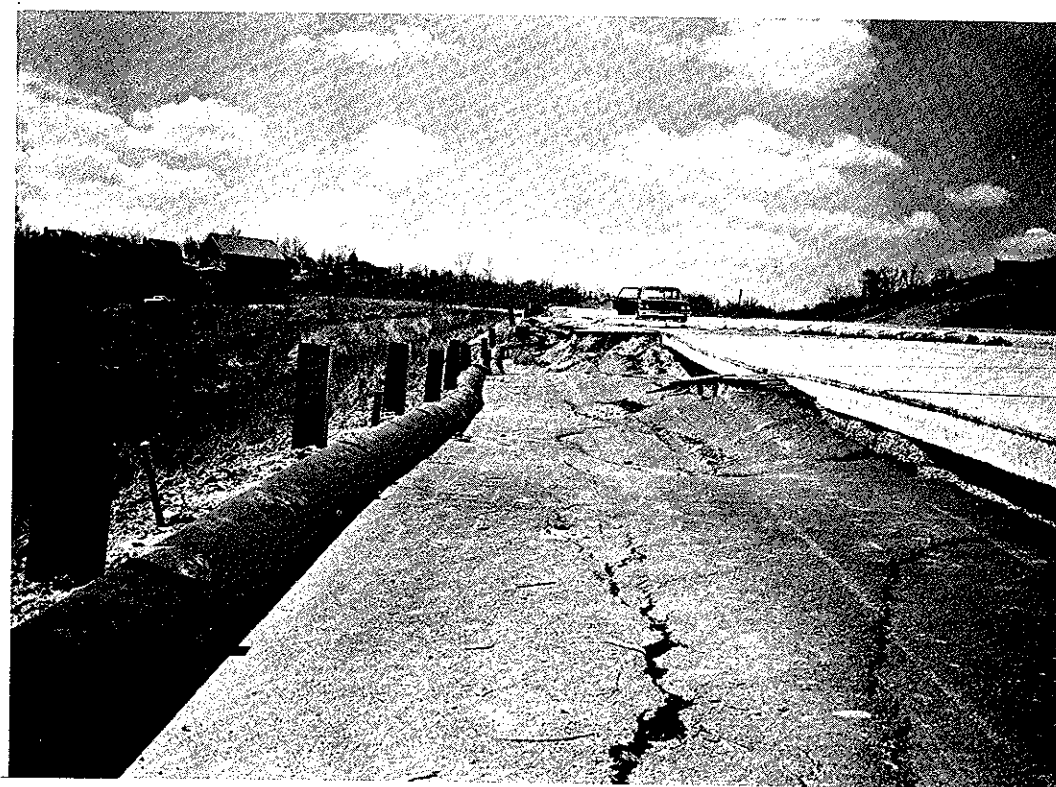
During the week of April 9, 1962, a significant amount of earth movement occurred near Station 487 and was sufficient to cause major damage to the essentially completed construction project. The site was visited by Division of Research personnel on April 16, 1962, and conditions were noted as shown in Figure 3. Figure 5, taken April 16, 1962, shows the extent of shoulder settlement. It was noted that the DGA base no longer supported the pavement, and the guardrail posts were out of alignment. There was a heavy clay embankment slope up to the shoulder pavement, thus preventing water from draining out of the DGA base.

The area of movement extended over a length of approximately 450 feet from Station 486+50 to 491+00. The toe of the slumped mass had moved out and over the embankment approximately two feet and was approximately one foot high.

Figure 5. Area of Major Distress (Looking South), April 16, 1962.

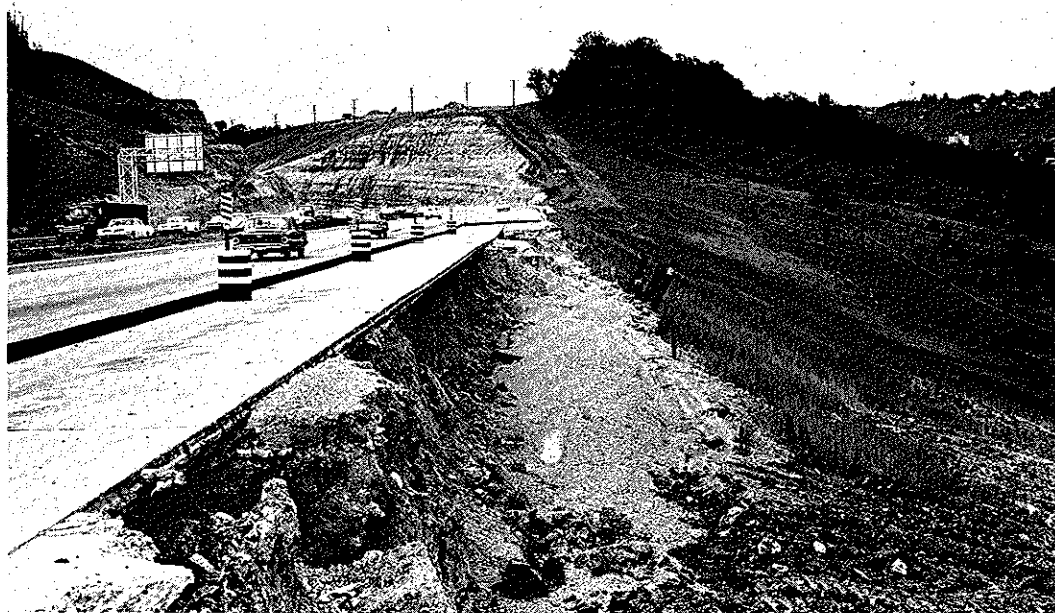
The embankment continued to slide, causing the timber piles to bend and in some cases to move vertically with the unstable material, as shown by Figure 6. Telephone poles and the fence lines showed massive toe movement

Figure 6. Main Scarp of Landslide Showing Pavement Slab Settlement, May 22, 1963 (Looking North).

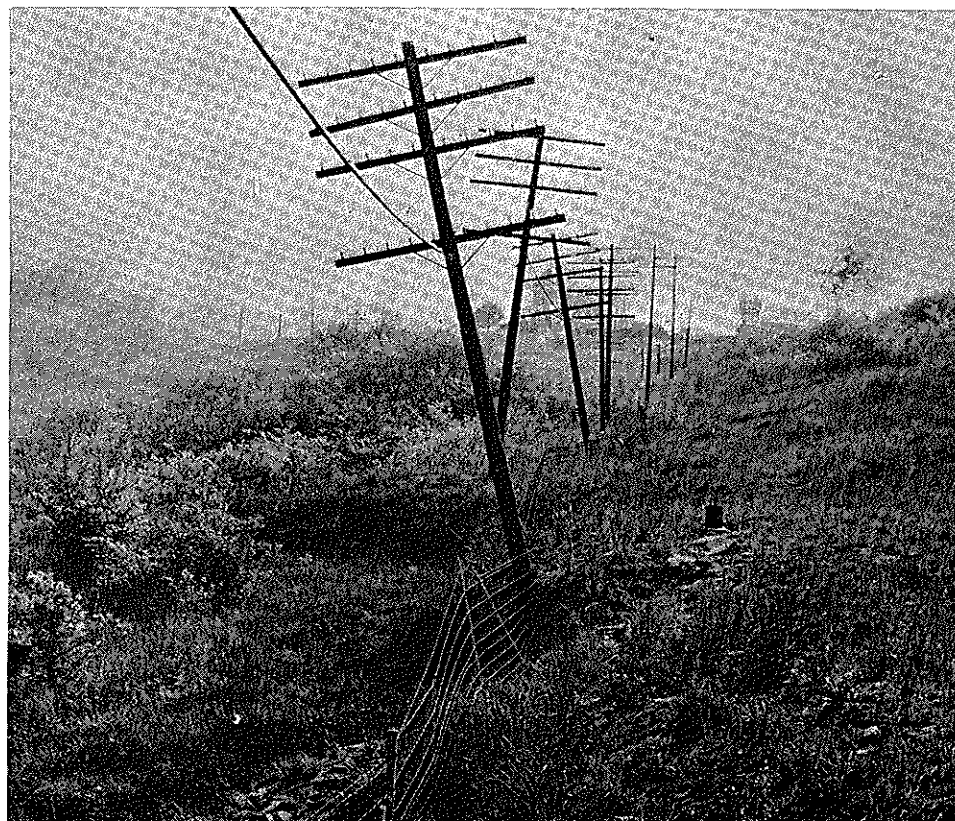
(Figures 7 and 8) and by May 10, 1963, the embankment had started to move over the junction box to the 4-foot by 4-foot box culvert at Station 489+50 (Figure 9). By May 22, 1963, the main escarpment had dropped over eight feet, as shown in Figure 10. The slope of the embankment was dressed to reduce water infiltration, and the rate of movement decreased. However, Figure 11 shows that by July 11, 1963, a well developed crack had reappeared in the slope, suggesting continuing movement.

Figure 7. Condition Near Toe of Embankment, May 10, 1963 (Looking South).

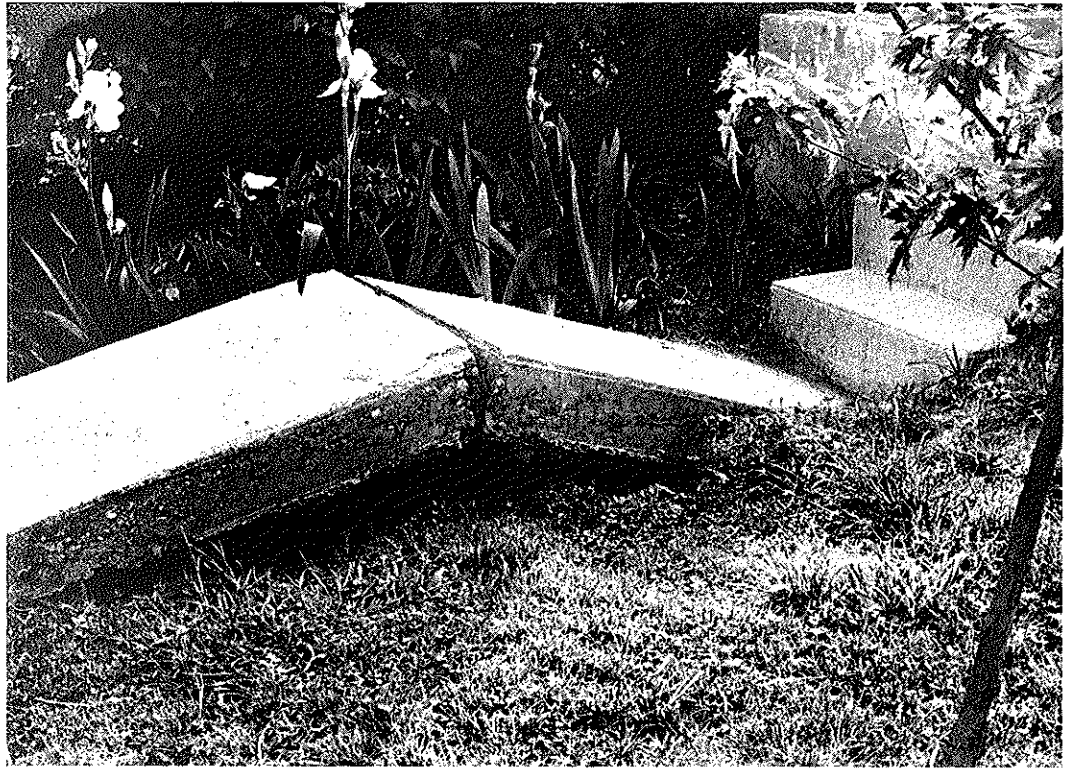
Figure 8. Buckled Sidewalk, Near Residence at Foot of Slope, May 10, 1963.

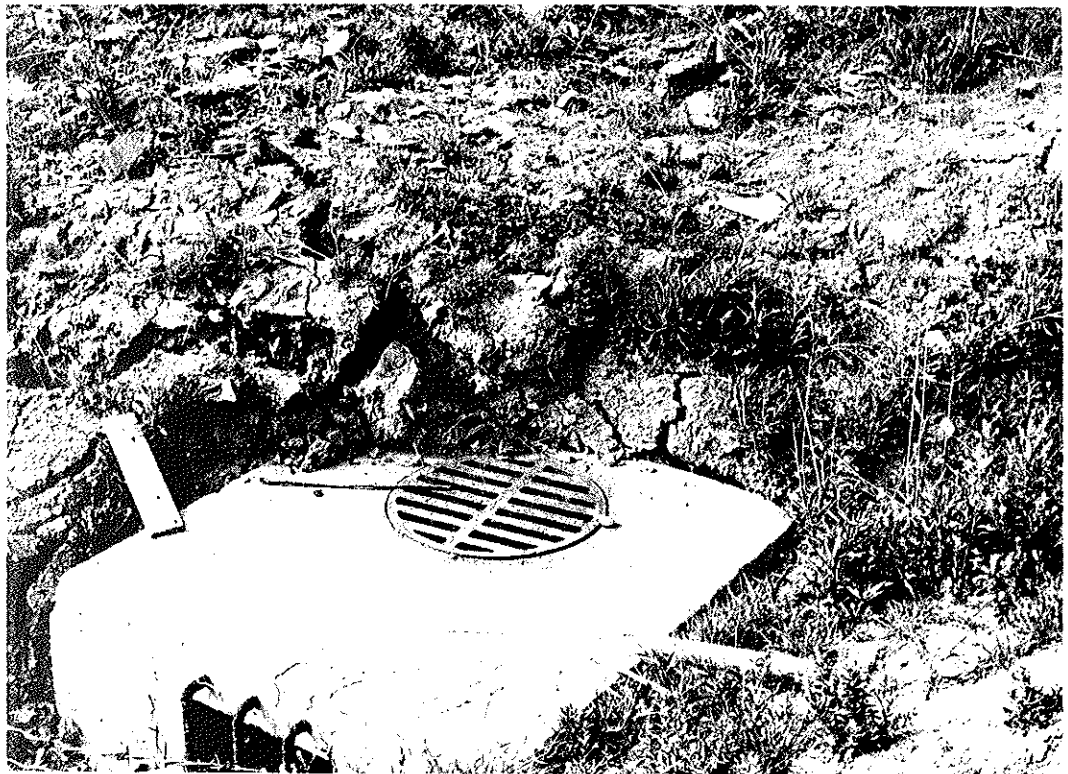
Figure 9. Soil Flow Over Junction Box, May 10, 1963.

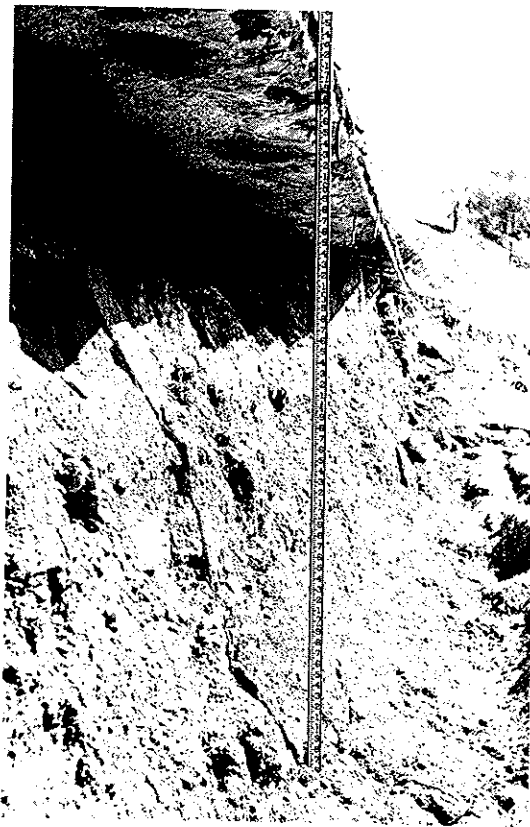
Figure 10. Main Scarp of Landslide, May 14, 1963.

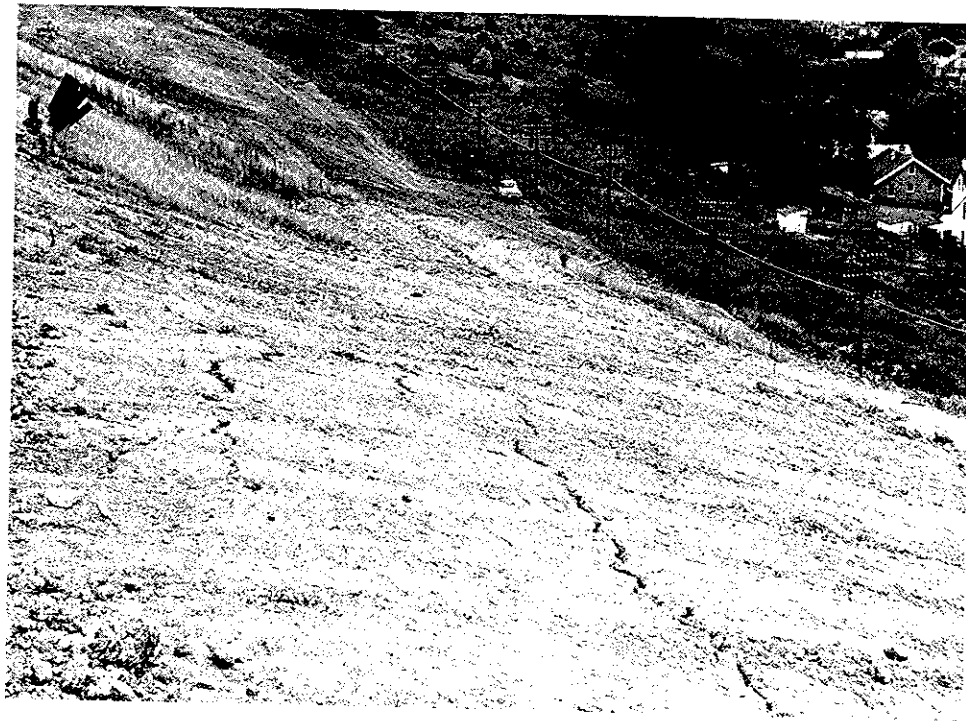
Figure 11. Condition of Slope, July 11, 1963 (Looking North).

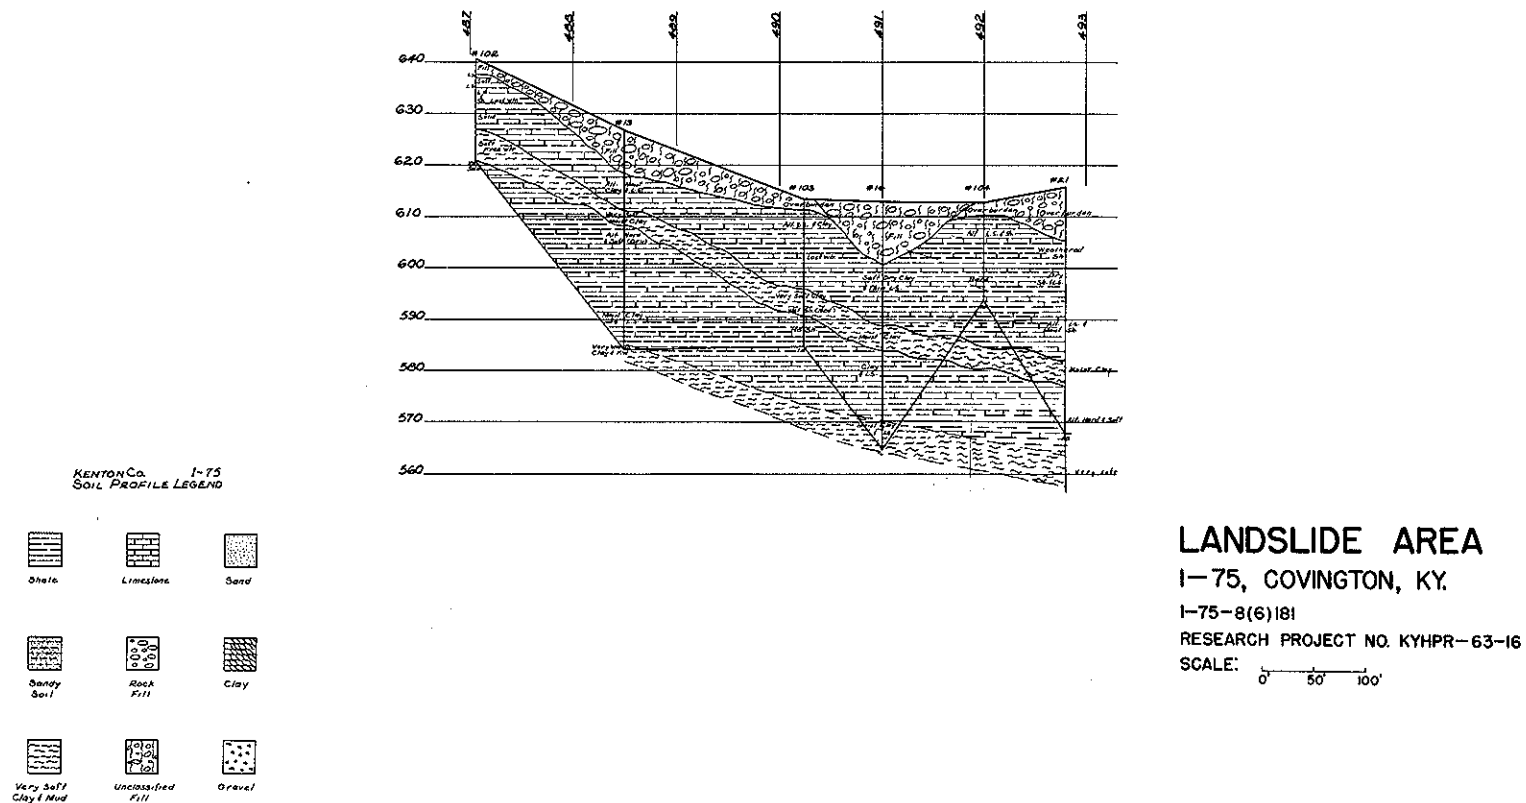
There was a zone of wet clay at an elevation of 690 to 700 feet at Station 486+50. A similar material was found at Station 485+00 at an elevation of 700 to 710 feet. The profile in Figure 12 shows the continuation of this wet layer. A second, extremely wet layer was also noted at greater depths. This top, moist layer could represent a connection between the Dickman Lake basin and the landslide area -- which would permit the passage of water into the landslide area as the basin filled and overflowed. An additional drainage path between the basin and the slide zone may have been created in the summer of 1962 when a perforated pipe (backfilled with sand) was placed at a depth of 15 to 20 feet in the west ditch line.

Figure 12. Soil Profile, Line C (222 Feet Right of Centerline)
(Taken from Logs of Auger Holes, 1963).

Near Station 490, and 222 feet right of the centerline (see Figure 12), a 4-foot by 4-foot box culvert was located at an elevation of approximately 585 feet, just below the upper water-bearing layer. Visual inspection indicated that the culvert had sustained no structural damage, and it was concluded, therefore, that the culvert was located in stable material. The upper wet layer in Figure 12 was thought to be very weak and to be the zone in which movement and slippage was occurring.

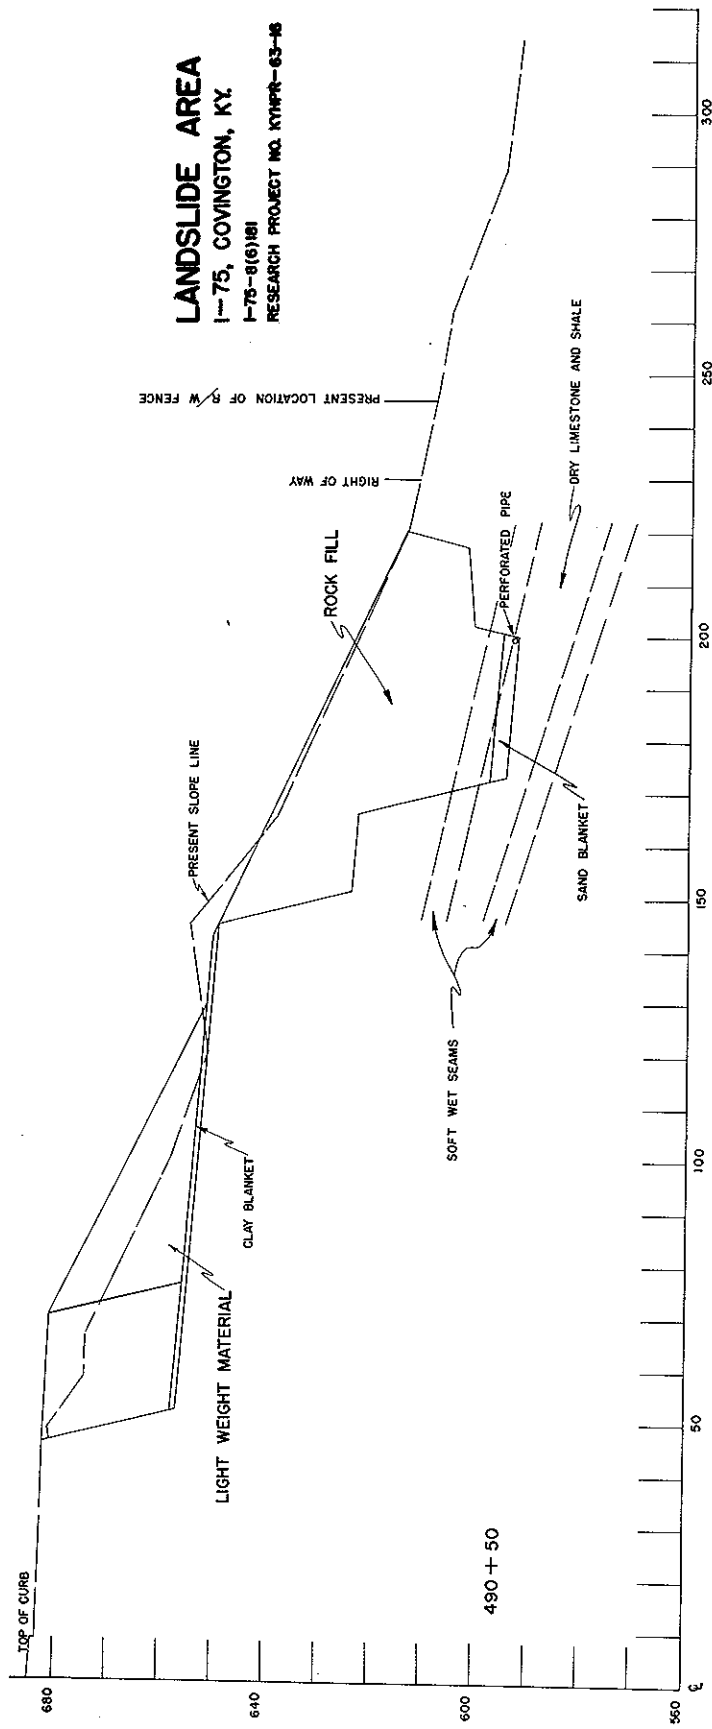
Figure 13. Typical Section Showing Planned Repairs of Landslide Area.

It was hoped that the above construction would be sufficient to stabilize the distressed area. However, a second phase was programmed to provide for the construction of a rock buttress (see Figure 13) near the toe of the embankment. By keying this lug into dry, firm bedrock, additional lateral resistance to movement would be available. The second phase also provided for the replacement of temporary pavement by portland cement concrete pavement after consolidation had ceased and the area was stabilized.

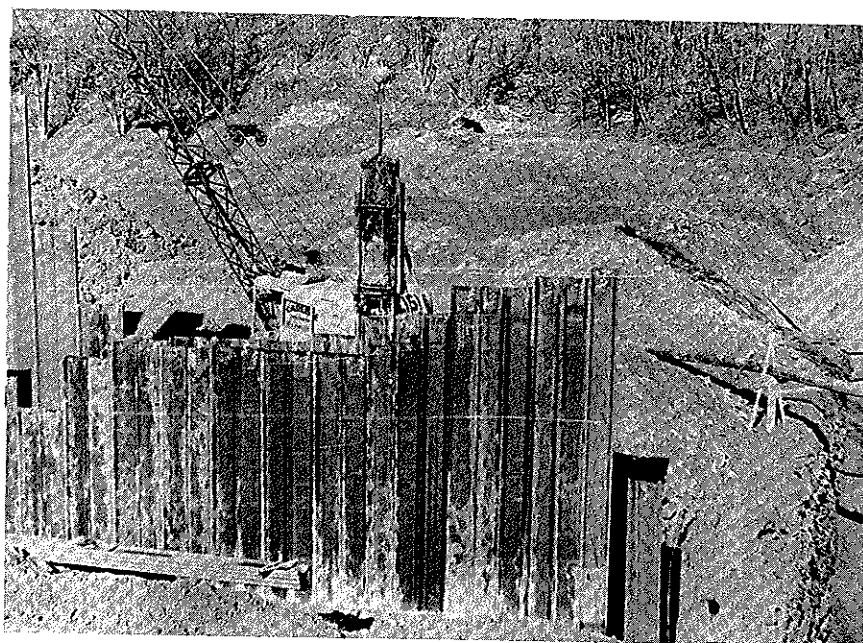
Figure 14. Construction of Cutoff Trenches in Dickman Lake.

After stabilization of the lake bed surface, the two cutoff drainage ditches were installed. This was accomplished by driving sheet piling on both sides of the trench line to depths varying from ten feet at the lake edge to 42 feet at the intersection of the trenches near the dam. In most places the sheet piles extended at least five feet into shale seams and (or) were driven to refusal. Material between the two rows of piling was removed by a clamshell bucket (see Figure 14). Sump pumps were used continually to remove water that seeped through the piling. Ten-inch perforated pipe was laid in the bottom and sand backfill was placed to within five feet of the lake surface. Clay fill was used for the remaining five feet. Upon completion of the two cutoff trenches, the piling on the upstream side was removed. The piling on the downstream face was left in place to provide a more positive seal or cutoff of seepage water.

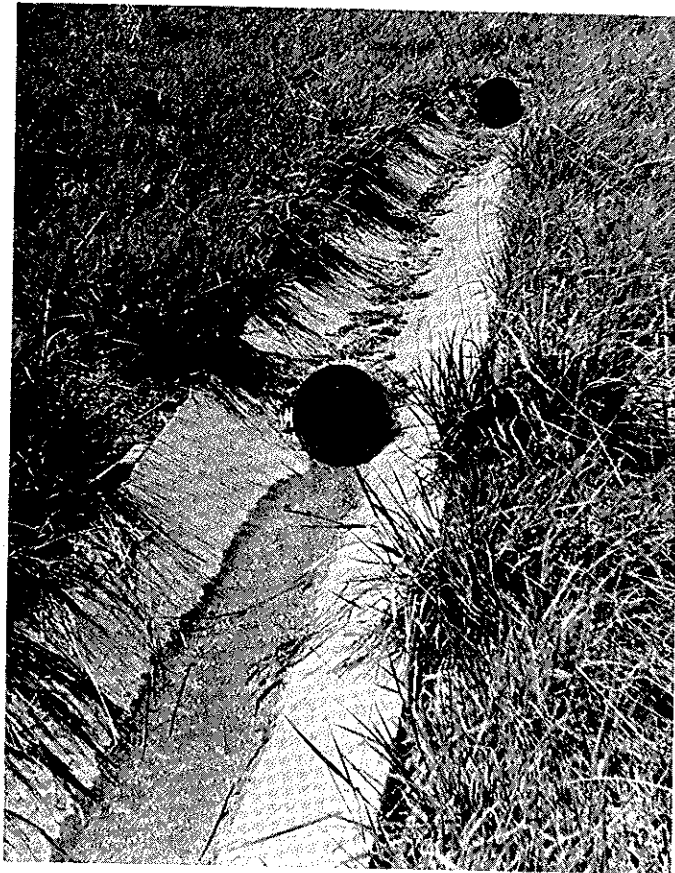
Figure 16. North Transverse Cutoff Trench Drain Pipes, May 1968.

Two cutoff trenches were installed across the interstate; the south trench was at Station 479+55, the north one at Station 486+33. Both trenches were installed by driving two rows of sheet piling, excavating from between the sheet piles, placing 10-inch perforated pipes at two different elevations in each trench, and backfilling with sand. The piling on the upstream, or uphill, side of each trench was then removed. The pipes in the south trench were installed 10 to 19 feet below the pavement surface, and in the north trench they were 11 and 21 feet (Figure 16) below the pavement.

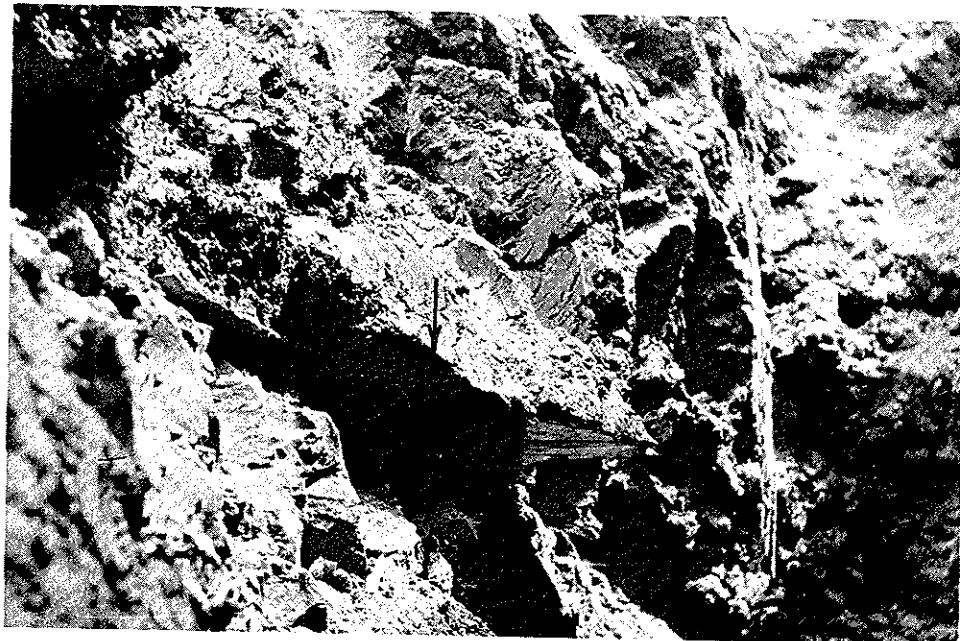
Figure 17. Major Slip Plane in the Trench at the Toe of the Original Embankment.

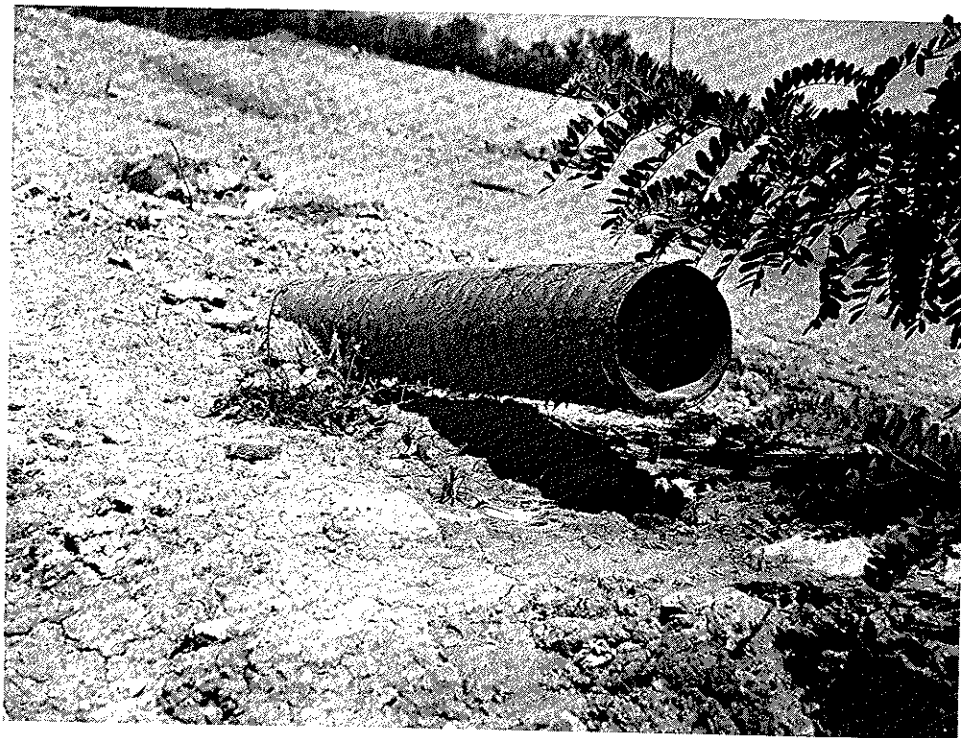
The only lateral drain that has had any water flow to date is the one at Station 490+50 (Figure 19). Water is still flowing out of this lateral at a variable rate but generally averages less than one gallon per hour.

Figure 19. North Lateral Drain Pipe.

The north lateral connected to the cutoff trench parallel to the toe of the old 2:1 slope flowed between two and three gallons per hour upon installation. Water has never ceased to flow from this pipe; however, the flow is presently in terms of drops of water. The flow rate decreased sharply upon completion of repairs to the broken 42-inch concrete sewer pipe. The odor of raw sewage is pronounced in this pipe at the present time.

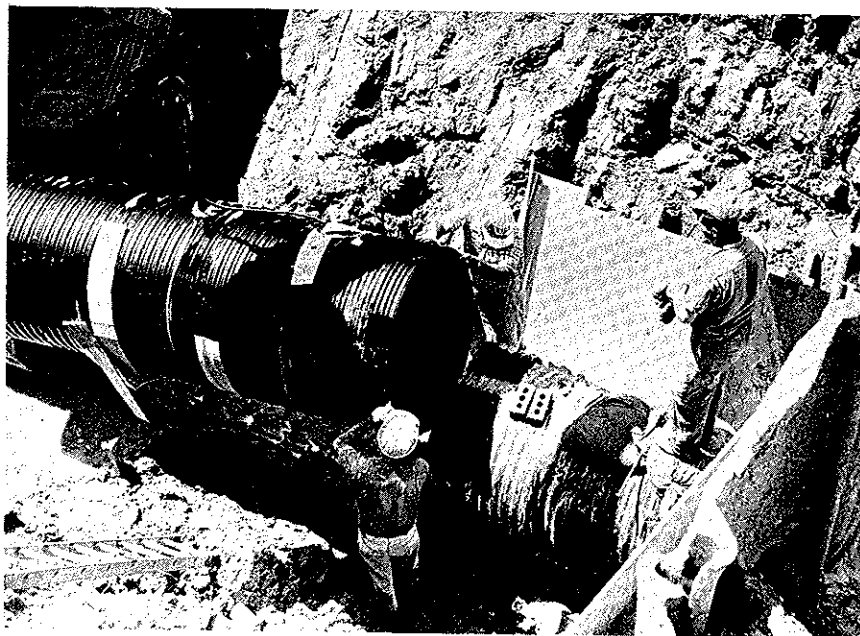
Figure 21. Corrugated Pipe Replacement for Broken Box Culvert.

with the elevation of the major slip plane observed in other portions of the cutoff trench. Sheet piles were driven above the damaged culvert and the fill excavated. The damaged sections were removed, and an 18-foot length of bituminous coated steel pipe was installed to join the undamaged ends (Figure 21). The hole was backfilled with clay material, except where the toe cutoff trench crosses the area; sand was used as the backfill material in this zone.

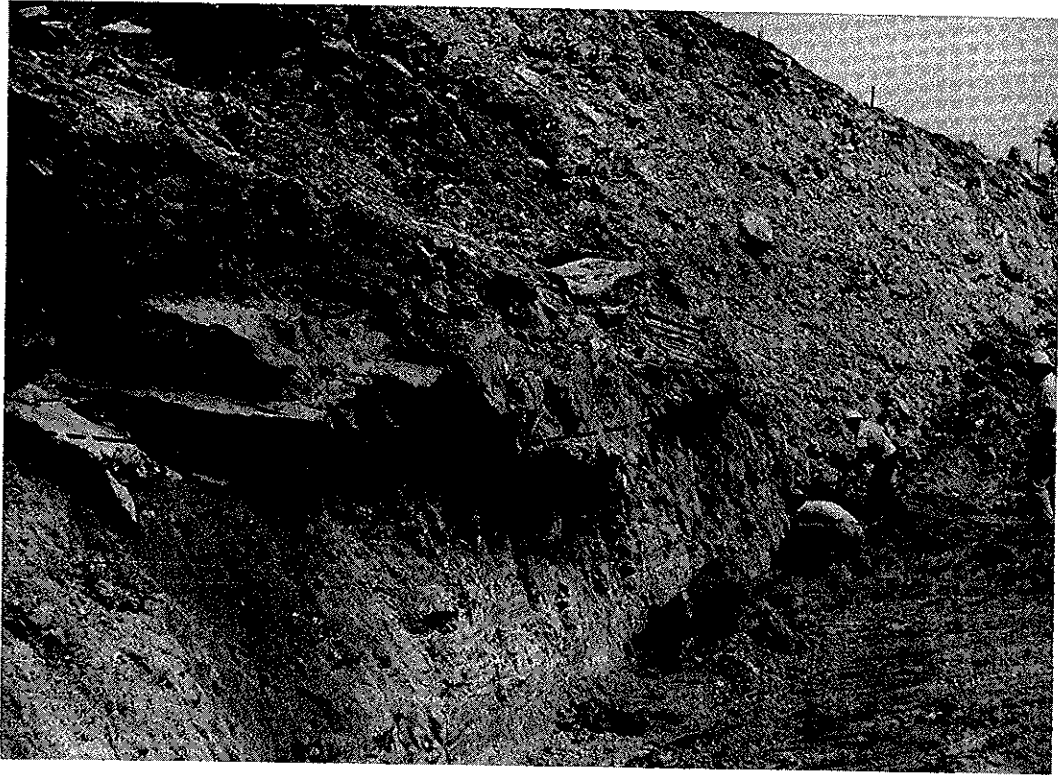
The material removed from the benches was used to construct the 4:1 fill. The south bench was brought to grade first, and the excavated material from the north bench was used to partially backfill the south bench. Considerable slippage of fill material from above the benches was noted during this operation (Figure 24).

Figure 24. Slip Plane in South Bench.

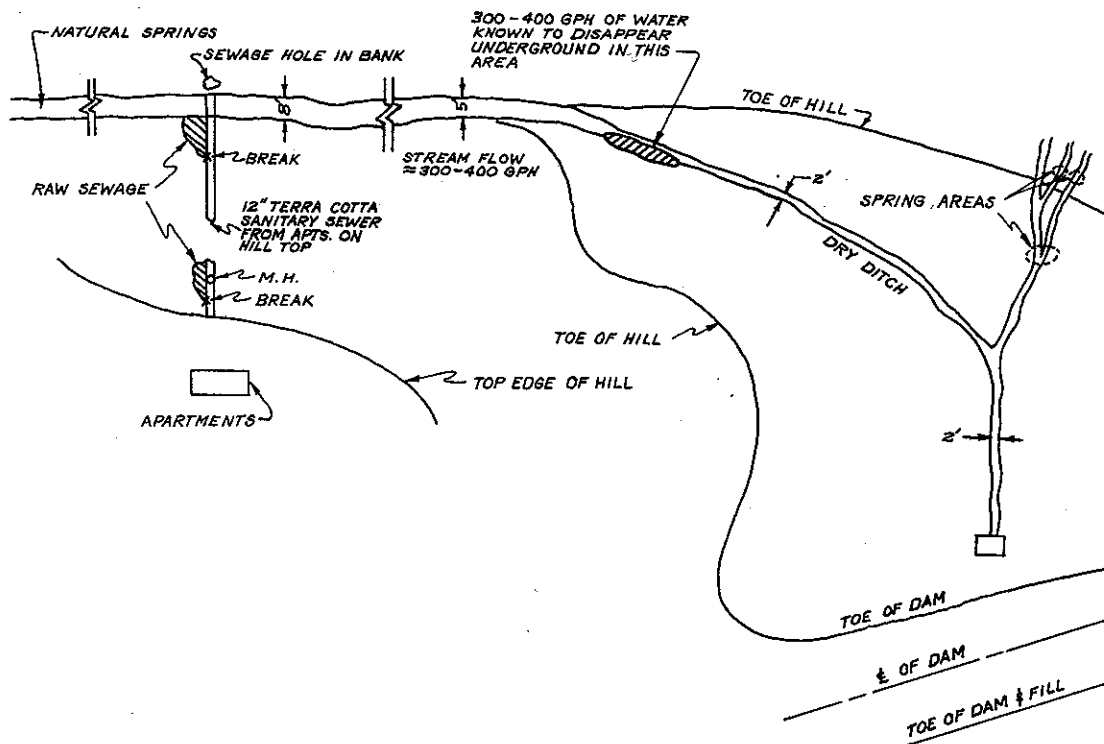
The alternately wet-dry areas on the slope of the embankment in the major slide zone would appear to be in the original natural drainage path from the valley left of Station 489+50. On April 26, 1968, an inspection of this valley revealed a large quantity of water flowing toward the drop inlet to the 4-foot by 4-foot box culvert located under the embankment (Figure 27). It was observed that the quantity of water reaching the box inlet was considerably less than that coming from the valley. The water flow coming from the valley was approximately 300 to 400 gph at a point 200 feet from the inlet, yet 55 feet from the box inlet, the ditch bottom was dry. Two areas were found in the ditch bottom where water was seen to disappear underground.

Figure 27. Sketch Showing Locations where Surface Water Was Observed to Disappear Underground.
